Inspection Report

Minerals Regulatory Program

Mine Name: Bonanza Mine	Permit Number: M/47/0010	Permit Fees: Paid	
Operator Name: American Gilsonite Company	Inspection Date: 08/20/2014	Bond Amount: \$546,000.00	
Inspector(s): A. Abate	Time: 12:00 PM	Bond Escalation: 6/2012	
Others: Dean Richins, Nick Lott-Company; V. Hughes, S.

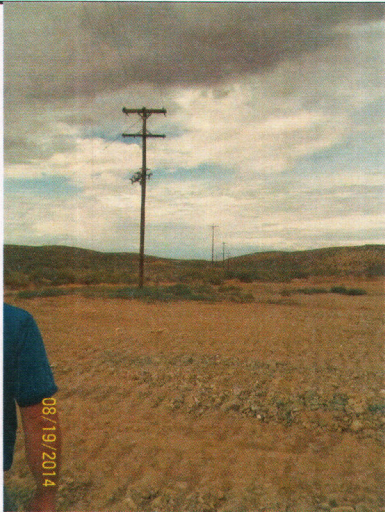
This is located on private ground and was totally reclaimed.

<p>NO VEHICLES BEYOND THIS POINT AREA UNDER RECLAMATION</p> <p>08/19/2014</p>
<p>Wagon Hound 17 reclamation area.</p>	<p>Wagon Hound 18 reclamation area.</p>

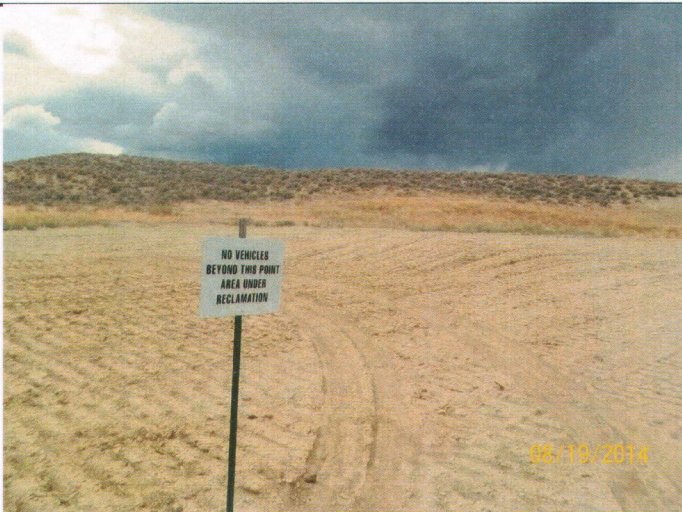
Half BLM, half private. Totally reclaimed with the exception of the access road which cannot be reclaimed until the power company pulls the power lines out, then the road will be reclaimed.

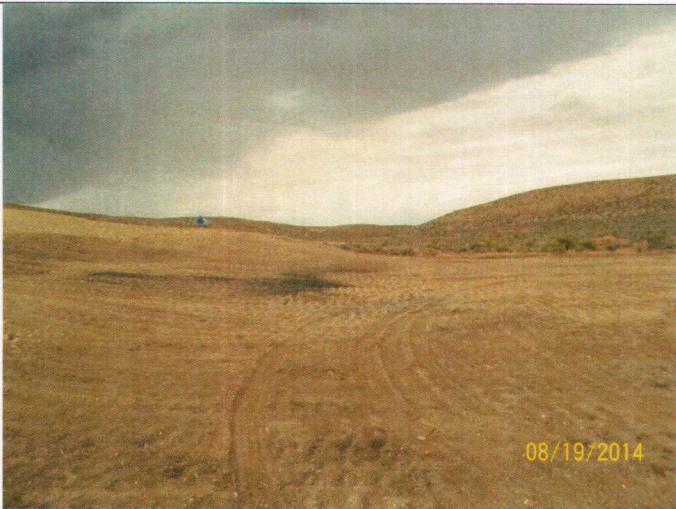
This is located on BLM ground. Some Gilsonite staining was on the ground. Clark, the mine manager said he would clean it up. Otherwise, the site is totally reclaimed.

<p>08/19/2014</p>
<p>Wagon Hound 19 reclamation area. Note gilsonite staining in the background.</p>	<p>Sample of native vegetation near the Wagon Hound 17,18,19 areas.</p>

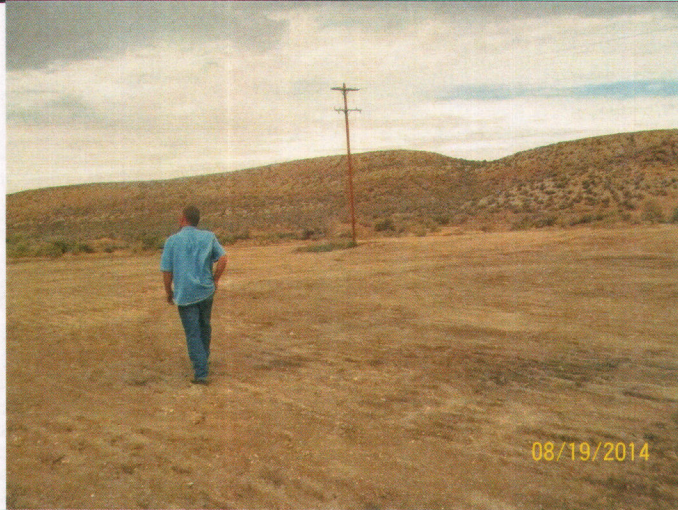
Wagon Hound 19 area still has power lines. These power lines will be removed by the power company. Once that happens, the access road will be reclaimed.

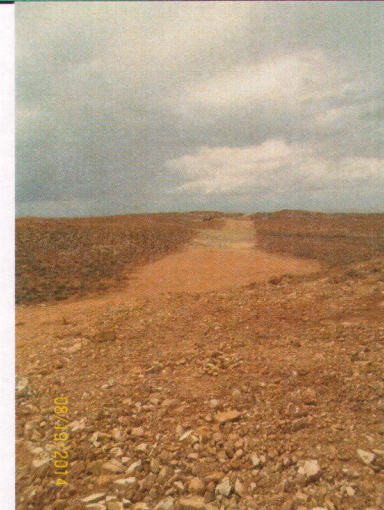
Little Emma 20 reclaimed area.

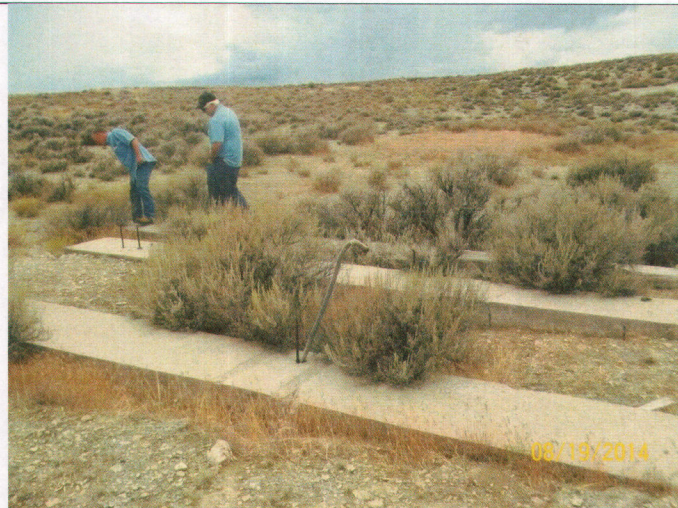
This is located on private ground. The site is totally reclaimed with the exception of the hoist house foundation on the side of the road. Clark said that would be removed. Everything else looked good.

Little Emma 20 area still had the remains of a hoist house. This foundation will need to be removed.

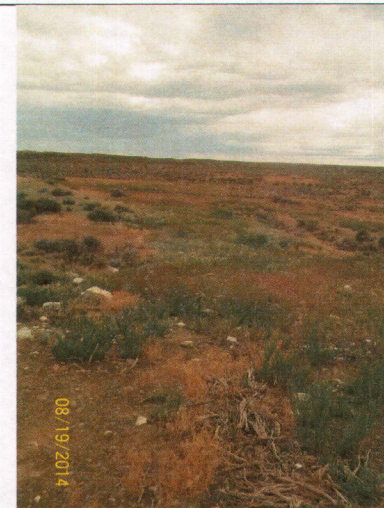
This site was on SITLA but it was turned over to BLM. This site was reclaimed about a year ago. Former SITLA, now BLM. Vegetation was growing the problem is it was halogeten. I asked Dean Richins if he was using certified weed-free seed and he indicated it was. Halogeten weeds unfortunately are a problem in this region. They grow first, then eventually get out competed by the other plants. Will continue to watch.

Little Emma 8 East. This site was reclaimed about a year ago. Vegetation was growing but the problem was that it was mostly halogeten.
